Case Report

Report on Italy Earthquake (24th August 2016)

On 24 August 2016, a magnitude of 6.2 earthquake hit the Apennines Mountains in central Italy, devastating the small towns of Amatrice, Accumoli and Pescara del Tronto. At least 293 lives were lost. This is the latest in a series of heavy earthquakes to hit Italy in recent years. The country is particularly exposed to earthquakes risk as it is located where continental plates collide and building stock is vulnerable. Yet just over 1% of residential buildings are insured against earthquakes. How can Italy and its residents better prepare for future events?

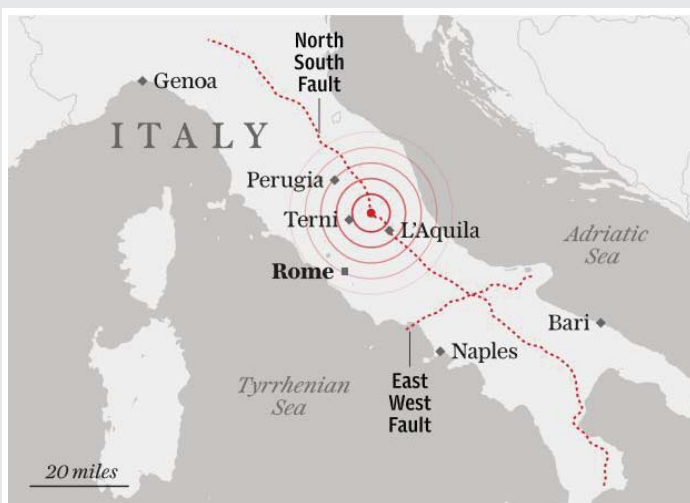
Figure 3: Epicentre of Earthquake.

The powerful earthquake ripped through central Italy on Wednesday, killing hundreds and leaving thousands homeless. The 6.2 magnitude earthquake has killed at least 241 people, the country's civil protection agency said on Thursday morning after rescue efforts continued through the night. The central Apennines is one of the most seismically active areas in Italy. The Apennines mountain belt were formed in the Miocene to Pliocene as a result of the ongoing subduction of the Adriatic Plate beneath the Eurasian Plate, forming a fold and thrust belt. During the Quaternary, thrust tectonics gave way to extensional tectonics, with the development of a zone of normal faulting running along the crest of the mountain range. The extension is a result of either subduction rollback or the opening of the Tyrrhenian Sea. In the Central Apennines the zone of extension is about 30 km wide, closely matching the zone of observed extensional strain as shown by GPS measurements. Recent large earthquakes in this area have been caused by movement on SW-dipping normal faults (Figure 3).

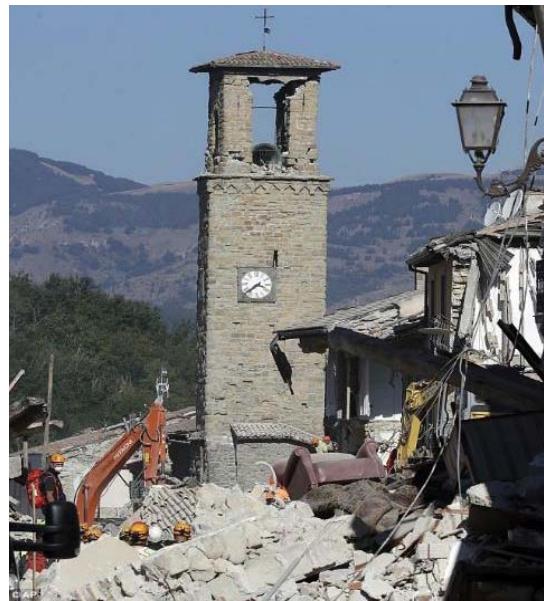
Italy is a developed country; it has a long history of earthquakes and a network. The real culprit is poor commitment to building hardened infrastructure. A large portion of the country's buildings date to the decades after World War II, when the population was booming, but construction codes didn't yet account for seismic hazards. While laws were updated in the 1970s, many of them have been ignored, even for hospitals and schools. Recently constructed buildings often fail disproportionately when the ground starts shaking. Major example supporting the above statement is a school building that promised to withstand powerful earthquakes after a 700,000-euro upgrade just four years ago has been left in ruins in central Italy, while a 13th century church bell tower managed to withstand the shock. The Romolo Capranica School in Amatrice was supposed to have been quake-proofed but completely collapsed on Wednesday when a catastrophic 6.2-magnitude quake struck at 3.30am local time. That was in sharp contrast to the oldest building in the town, the 13th-century Civic Tower, which was still standing on Thursday, despite having been shaken sufficiently to detach its bell from its fastenings (Figure 4).

Figure 4: Church tower of 13th century standing in middle of collapsed structures.

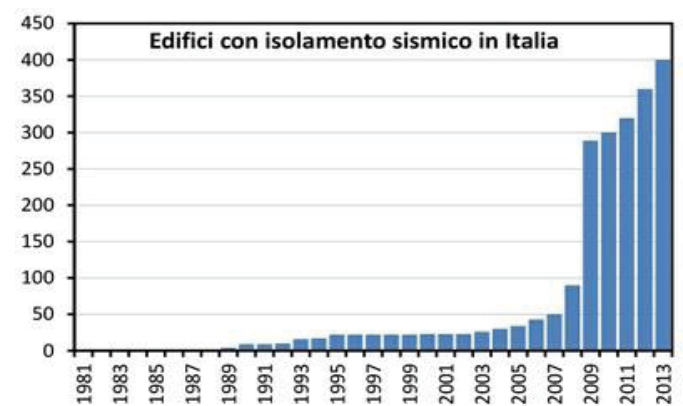
As of today, there are mainly three ways: the conventional method consists in making the structure strong enough to be able to withstand the strongest earthquake which is likely to occur at its site, another envisages the application of seismic isolation devices dramatically reducing the seismic forces transmitted from the ground to the structure, and the third incorporates both methods. Seismic isolation systems allow for much higher safety levels: a new seismic isolated building (if designed properly) can survive a potentially devastating seismic impact, also preserving its contents. It’s generally possible to install seismic isolation systems in new buildings and, in medium and high seismic areas, if well designed, with no additional construction costs. Globally, in 2013 the number of seismic isolated structures was over 23.000 in more than 30 countries: bridges and viaducts, civil and industrial buildings, facilities, including nuclear and chemical plants at risk of major accidents. The materials employed range from reinforced concrete to steel and even wood (Figure 5). Italy

Figure 5: showing Seismic isolated buildings in Italy.

has a leading position in Europe in the use of isolation and energy dissipation systems in buildings, bridges and viaducts and has strengthened its role after the Abruzzi earthquake in 2009: in the city of L’Aquila alone, the new buildings isolated with life-saving systems are more than one hundred, both new constructions and retrofitted existing buildings. Italy also holds a leading position globally in the use of AS systems for the protection of cultural heritage, having developed major projects in this sector; moreover, systems manufactured in Italy are also used in other countries, like Cyprus, Russia, Indonesia, Iran, Greece, Portugal, Spain, and Turkey and so on.
